**Phase I Environmental Site Assessment
Proposed Prince William Sound Center
Cordova, Alaska**

September 14, 2018

By:
Shannon & Wilson, Inc.
5430 Fairbanks Street, Suite 3
Anchorage, Alaska 99518
Phone: (907) 561-2120
Fax: (907) 561-4483

100619-001

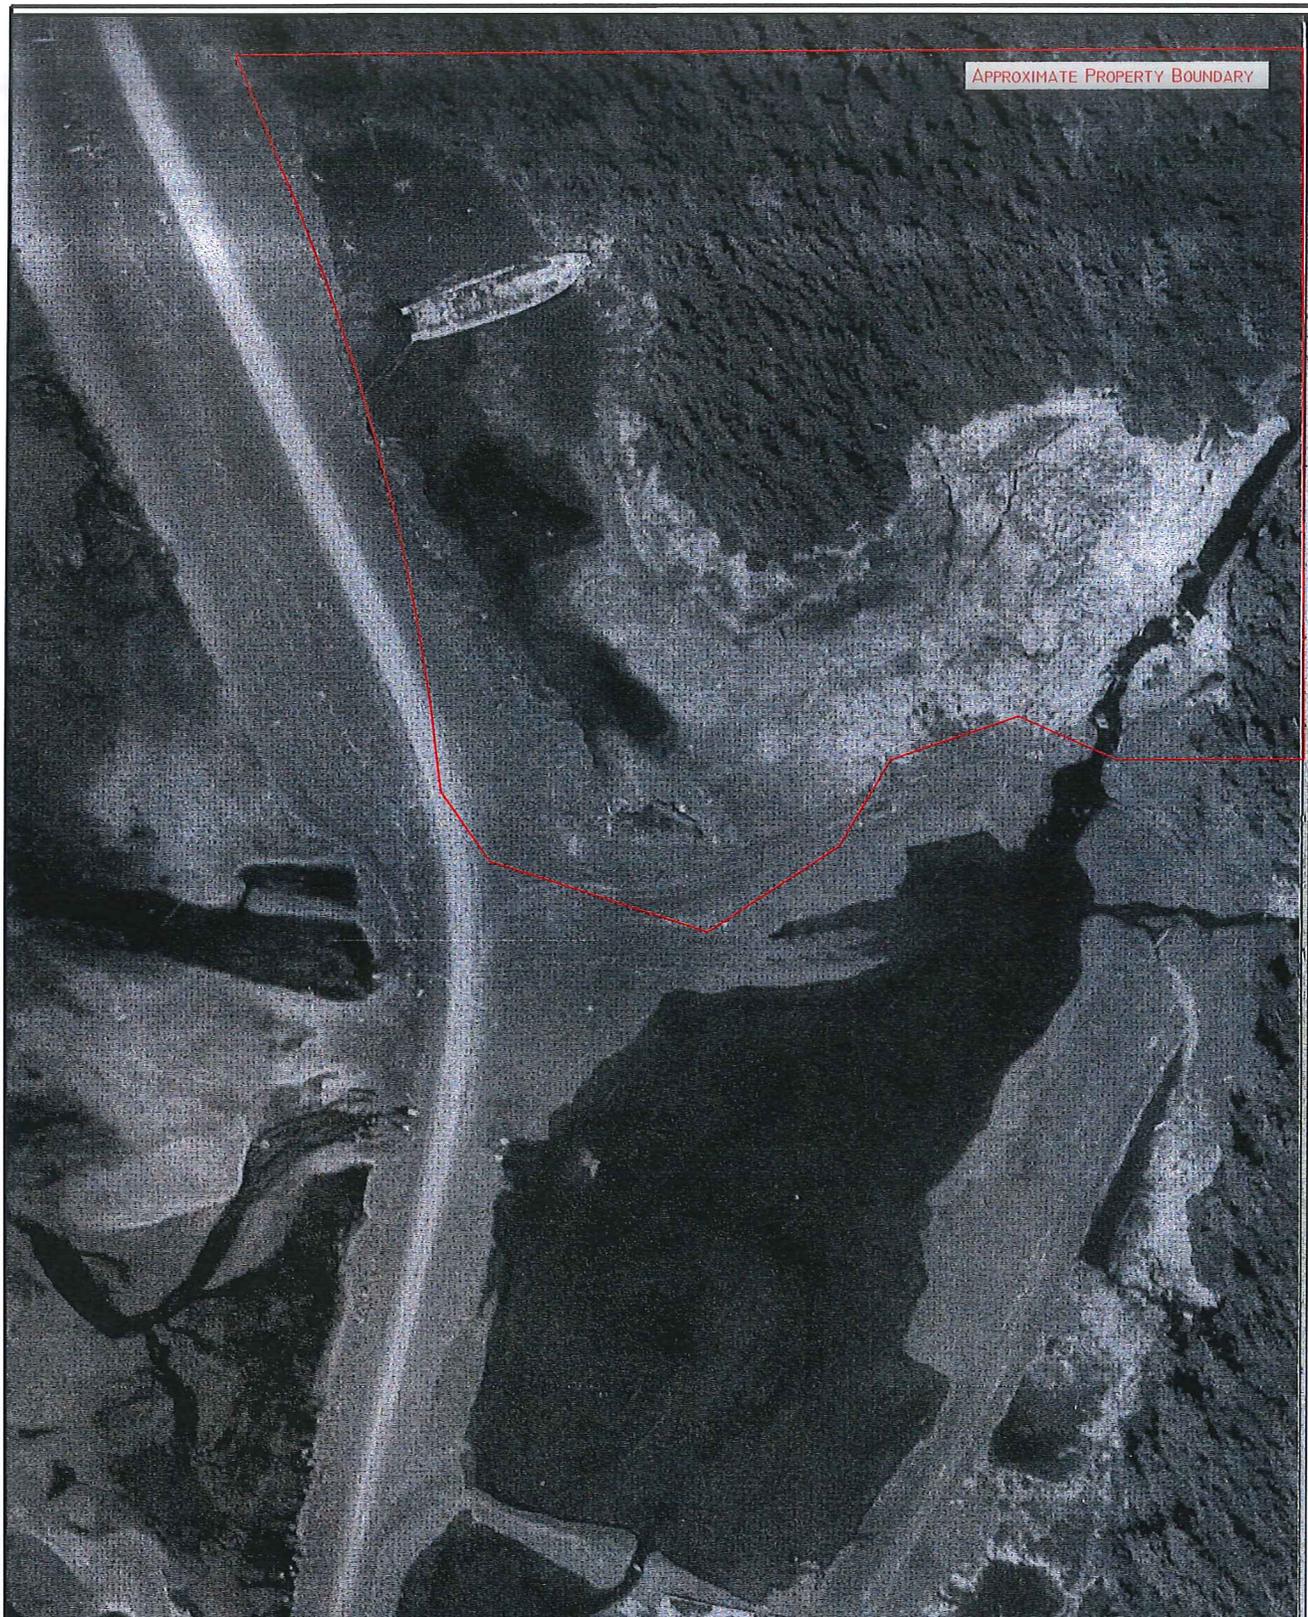
FIG. 3

Property or in the vicinity, Ms. Hoffman stated that there is a barge buried in the fill on the northwestern portion of the Property (see Figure 3 and Figure 4), and a community burn pile is located approximately 450 feet north of the Property. The completed Phase I ESA User Questionnaire is included in Appendix A.

AERIAL PHOTOGRAPH
JULY 3, 1972

- A barge, first seen in a 1972 aerial photograph, is buried beneath fill on the northeast portion of the Property. It is unknown whether the barge stored petroleum products or hazardous materials. Releases of petroleum products or hazardous materials from the barge could potentially impact the Property.

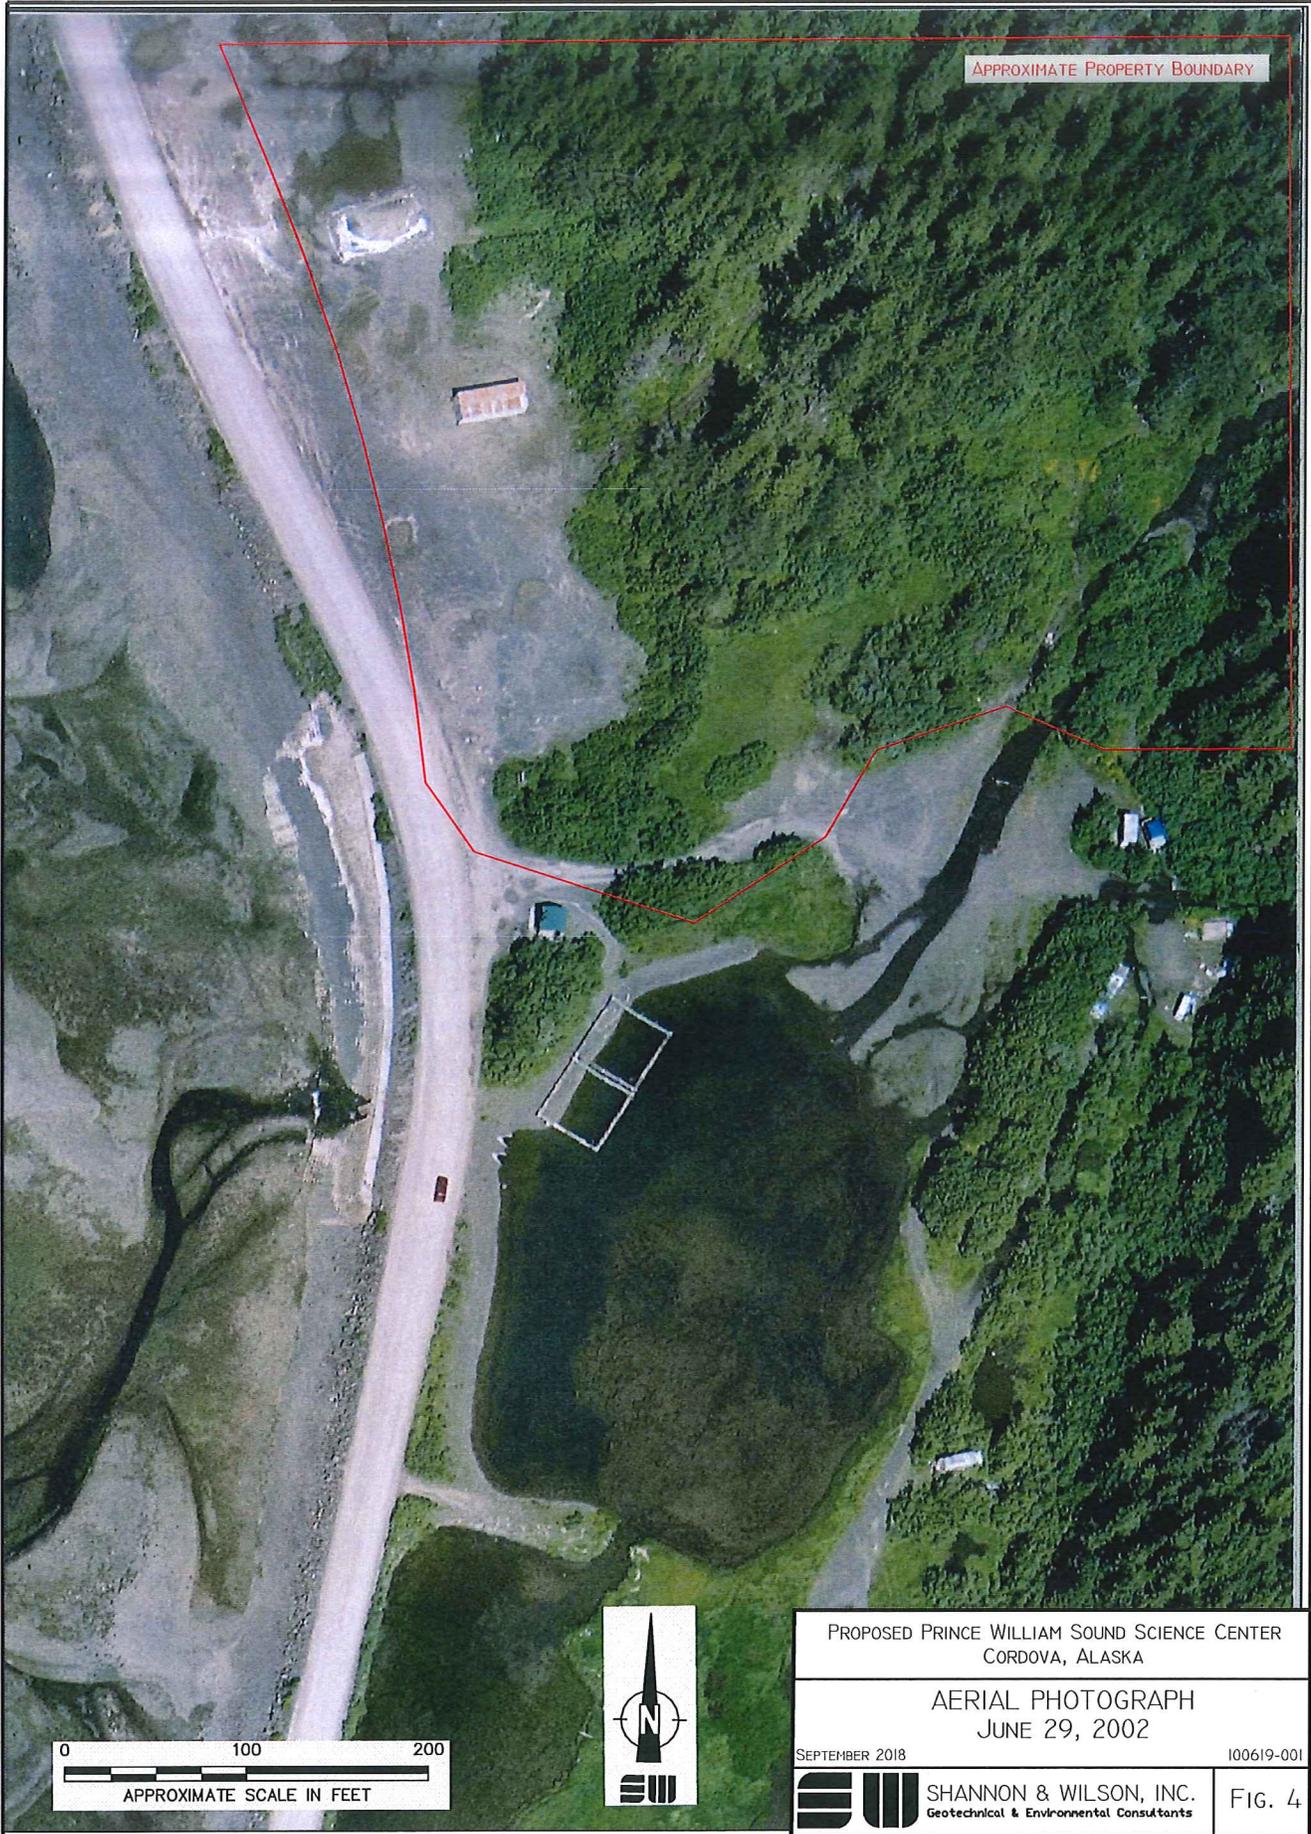
Aerial photographs from Quantum Spatial, Inc. were reviewed to evaluate prior land use in this area. The photos that are included in this report are from 1972 and 2002. These photos are included as Figures 3 and 4, respectively, and are each enlarged to an approximate scale of 1-inch equals 100 feet. The approximate Property boundary is shown in red on the figures for reference. Although not chosen to print, aerial photographs from 1959, 1969, 1973, 1976, 1981, and 1992 were also reviewed. Aerial photographs later than 2002 were not available from Quantum Spatial, Inc. or Google Earth for review. A summary of the aerial photo review follows:

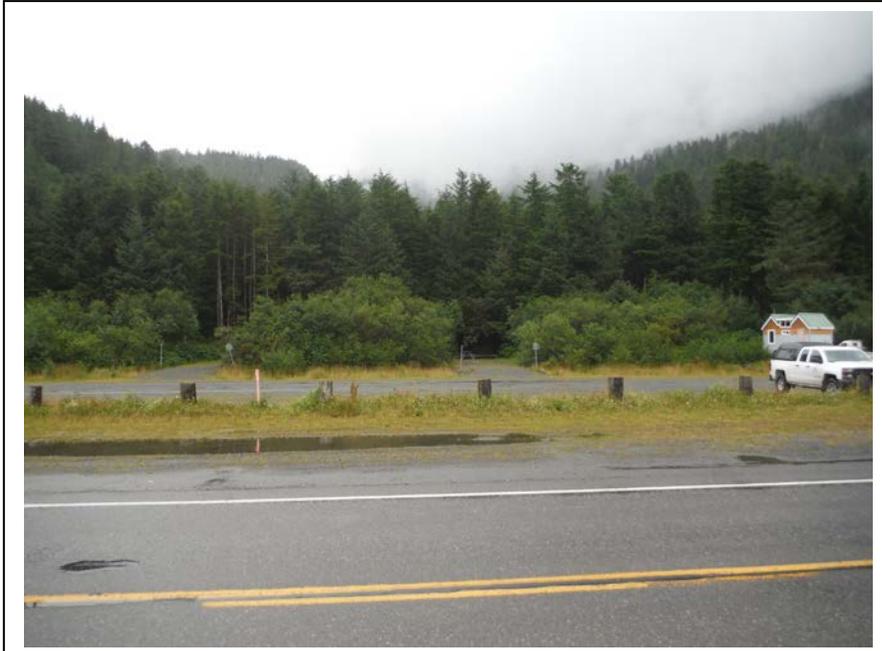
No permanent or temporary structures were observed on the Property. The western portion of the Property is a gravel fill pad used for day-use vehicle parking and overnight RV camping (Photos 1 and 2). Three "tent" campsites are situated along the western portion of the gravel pad. A gravel road, overgrown with vegetation and alders, was observed on the central portion of the Property. The road extends approximately 450 feet in a northeasterly direction beginning behind the campsites. A three-phase junction box is located on the southern portion of the Property, adjacent to New England Cannery Road (Photo 3). Fleming Creek is located on the southeast portion of the Property (Photo 4). Several campfire rings were observed along Fleming Creek on the eastern portion of the Property (Photo 5). Pallets, trash, and other debris were observed at the campfire sites.

Photo 1: Looking east across the southern portion of the Property.
(August 11, 2018)

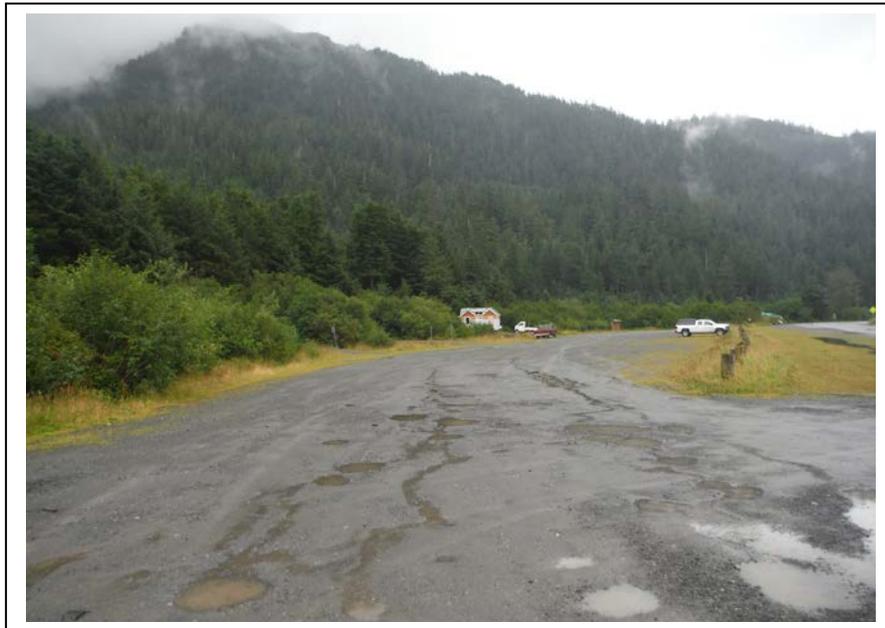
Photo 2: Looking south across the western portion of the Property.
(August 11, 2018)

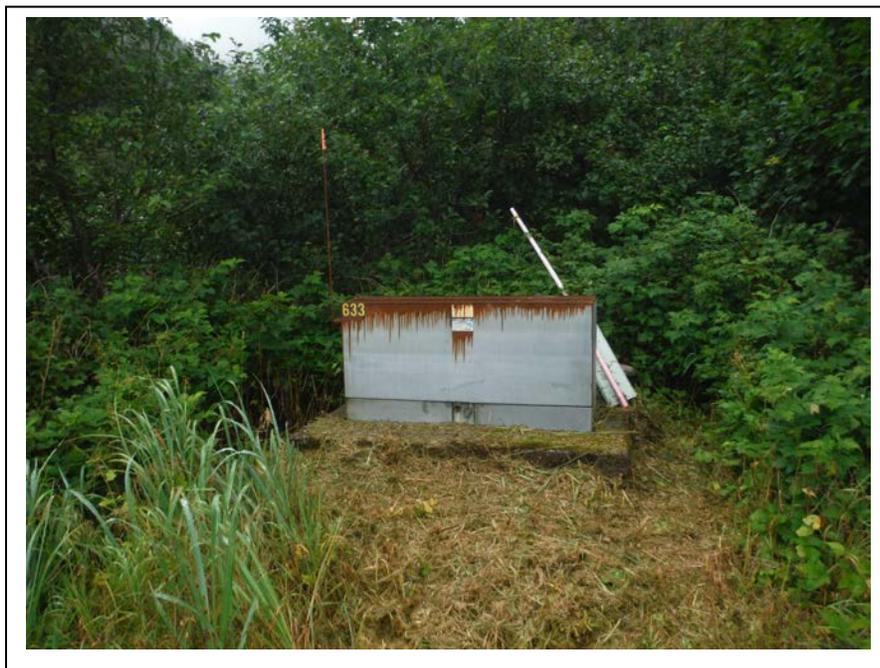
Photo 3: Three-phase junction box on the southern portion of the Property. (August 11, 2018)

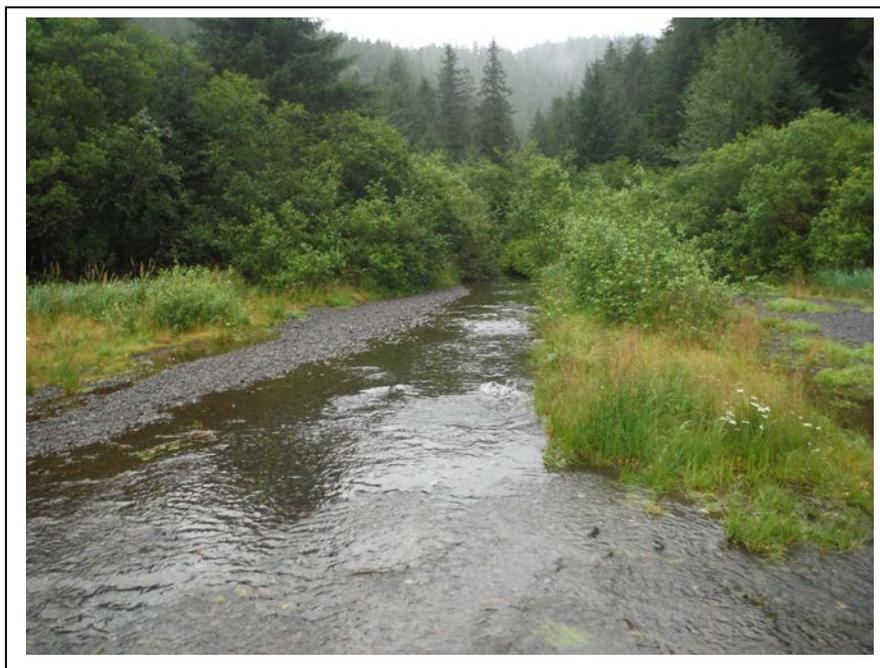
Photo 4: Fleming Creek on the southeast portion of the Property. (August 11, 2018)

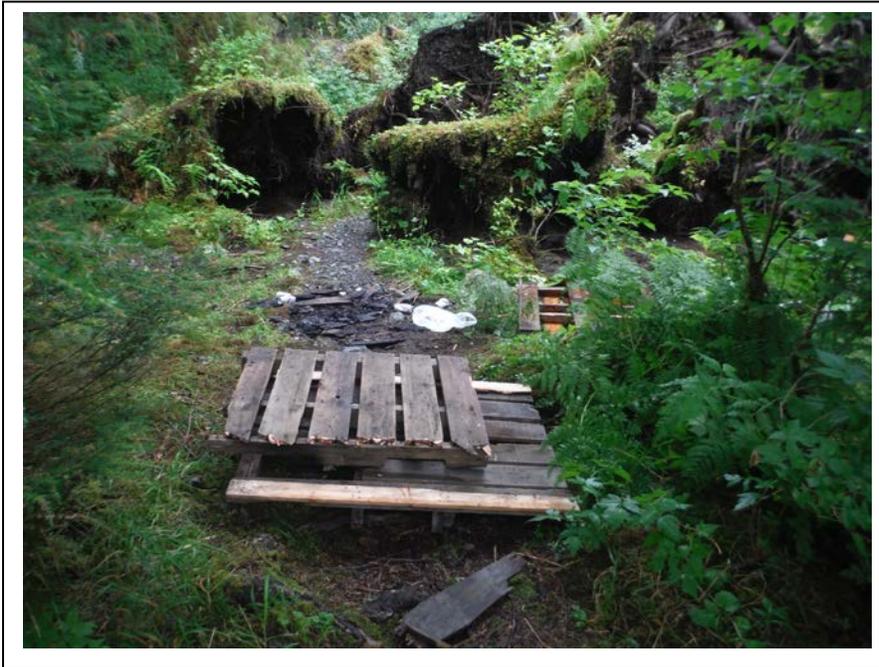
- Several campfire rings were observed along Fleming Creek on the eastern portion of the Property. Burn areas could pose environmental risk as petroleum hydrocarbons are often used to ignite the burn material and may impact the ground surface. In addition, combustion byproducts and residuals may include hazardous materials.

Photo 5: Campfire ring and debris located on the eastern portion of the Property. (August 11, 2018)

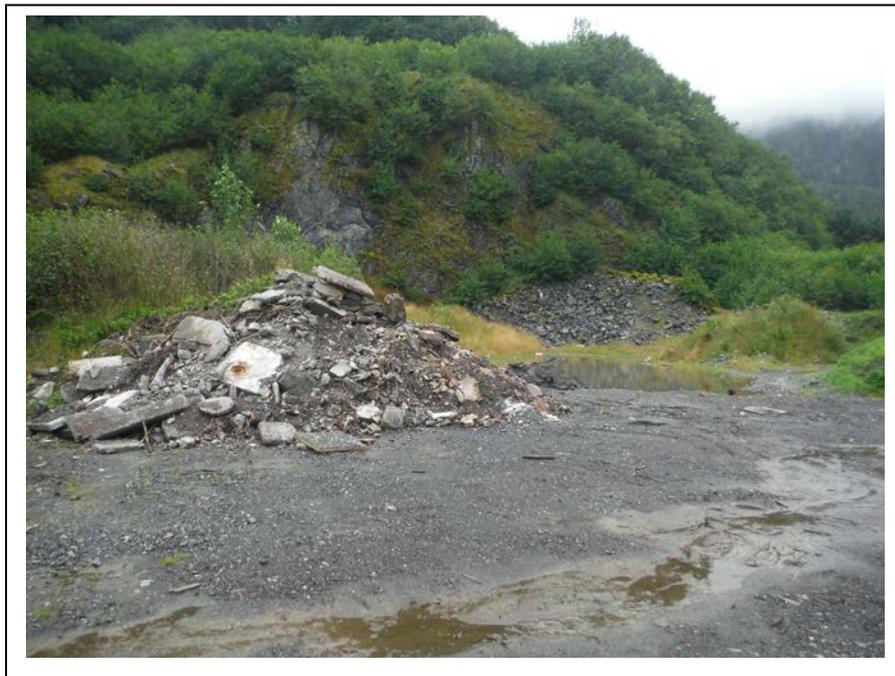
- A community burn pile is located approximately 450 feet north of the Property. According to Sam Greenwood, City Planner for the City of Cordova, it is unknown whether storage or disposal of hazardous substance or illegal dumping has occurred, although these actions are prohibited.

Photo 6: Community burn pile located approximately 450 feet of north of the Property. (August 11, 2018)

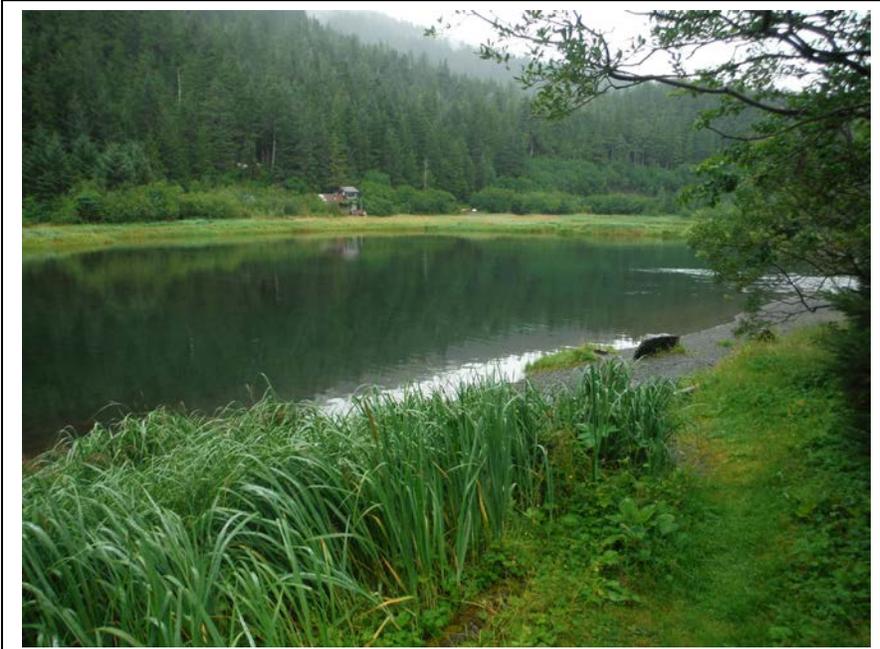
Photo 7: Pond located south of the Property. (August 11, 2018)
